**Alpha Home Inspections**  
<http://www.inspectwithalpha.com>  
(630) 340-7723  
[imiranda@inspectwithalpha.com](mailto:imiranda@inspectwithalpha.com)

**123 Main Street, Pleasantville, Illinois 12345**  
**Residential Inspection**  
**Prepared for**  
**John Doe, Jane Doe**  
**Dec 02, 2021 at 08:00 AM**

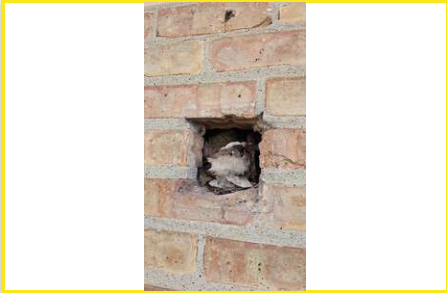
Location: LEFT SIDE (FACING FRONT)

3.1.1 Seal penetrations

The hole(s) in brick need closing off with sealant or liquid foam where lines for system components enter the home.

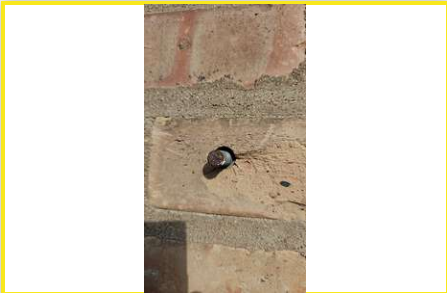
Location: RIGHT SIDE (FACING FRONT)

1.4 Through bolt

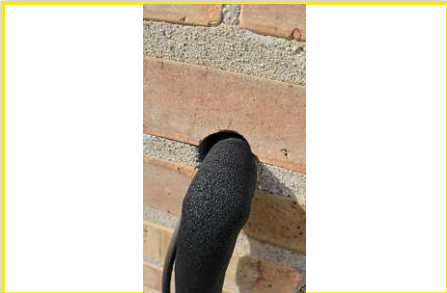
Location: REAR LEFT CORNER

1.5 AC lines

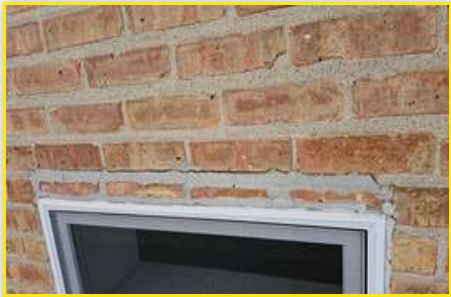
2.1 Unable to verify if a lintel is present

3.1.2 Damaged brick above windows

At the time of inspection, one or more bricks were damaged above windows due to missing/failing/rusted lintels or other reasons. I recommend the affected area(s) be evaluated and repaired or replaced as needed by a professional masonry contractor.

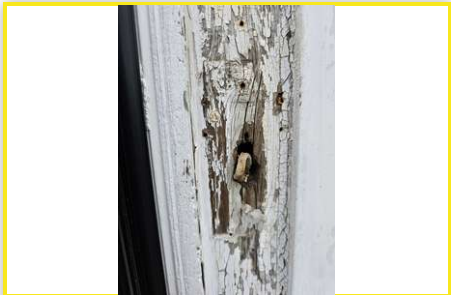
1.1 There used to be a doorbell here

3.2.1 Damaged trim

The trim on this home was, cracked, deteriorated or damaged. I recommend the affected area(s) be evaluated and repaired or replaced as needed, by a professional contractor, to seal out moisture. Should you consider doing the repair yourself, see the DIY linked video to assist you in your decision.

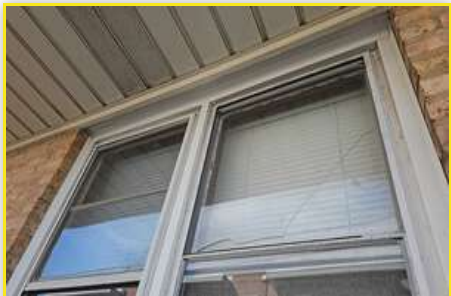
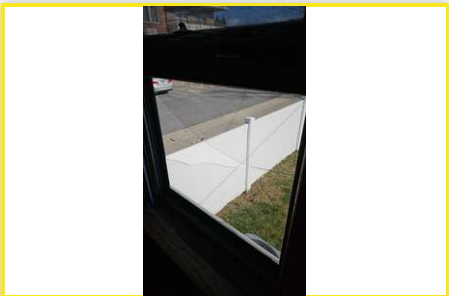
Location: LEFT SIDE (FACING FRONT)

3.4.1 One or more cracked/broken exterior windows

One or more exterior windows had cracked panes. Broken glass should be repaired or replaced to prevent injury and further damage. I recommend the affected area(s) be evaluated and corrected as needed by a professional contractor.

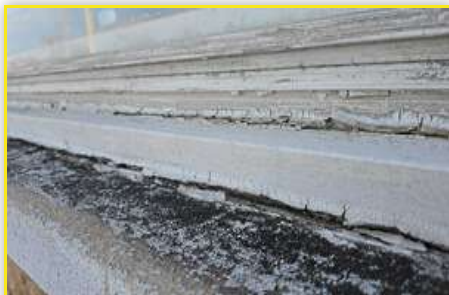
1.1 Windows

#### 2. PAINT FAILING IN SOME AREAS

There were areas of paint that were peeling off. This can lead to deterioration of the material underneath if not kept sealed. Also keep in mind that even today, many exterior paints today are still allowed to contain lead in the ingredients. Peeling paint should be scraped, sanded, and re-finished.

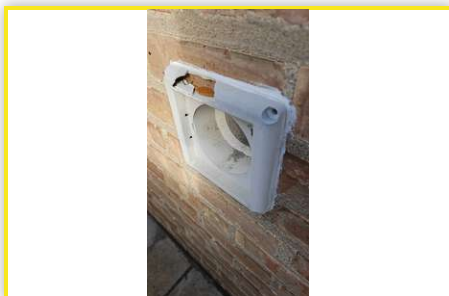
### 3.6.1 Vents and Misc. Problems(Multiple Defects)

There were one or more missing vent covers around the exterior or soffits. We recommend that all of the missing vents be installed as needed to keep insects and nesting rodents or birds out of the home.

At the time of inspection, one or more exterior vents were damaged. I recommend the affected damaged vents be evaluated and repaired or replaced as needed by a qualified person.

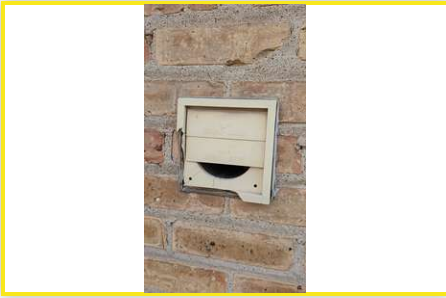
### 3.6.2 Missing vent flapper

At the time of inspection, one or more exterior vents was missing its flapper. I recommend that the missing vent flappers be replaced by a qualified person to prevent vermin intrusion or nesting.

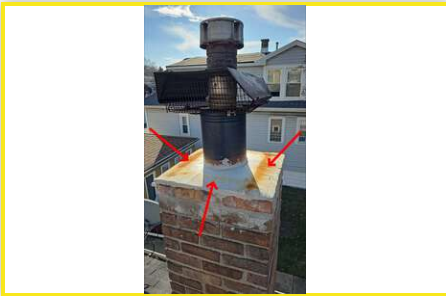
### 4.1.1 Improper crown

The cement crown on one or more chimney(s) is inadequate and will not direct water away from the structure. A chimney crown should overhang the stack by at least 1-2 inches and allow a capillary break for water to fall before weeping onto the brick. The cement should also be 2 inches thick and the thinnest and have a slope away from the flue opening. I recommend a qualified masonry contractor further evaluate and repair or replace as needed.

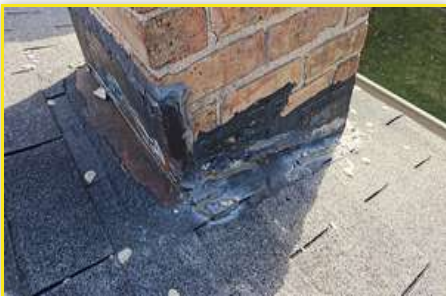
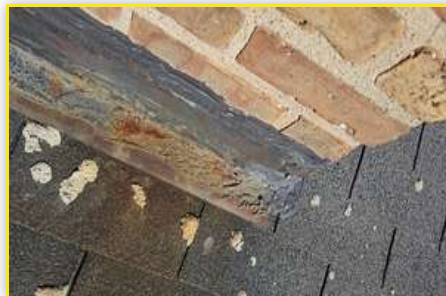
### 4.2.1 Damaged, loose missing flashing

At the time of inspection, there was visible loose, damaged or deteriorated roof flashing, allowing for potential leakage, causing damage, decay or mold. The Inspector recommends that the affected area(s) be evaluated, replaced or repaired, as needed, by a professional roofing contractor.

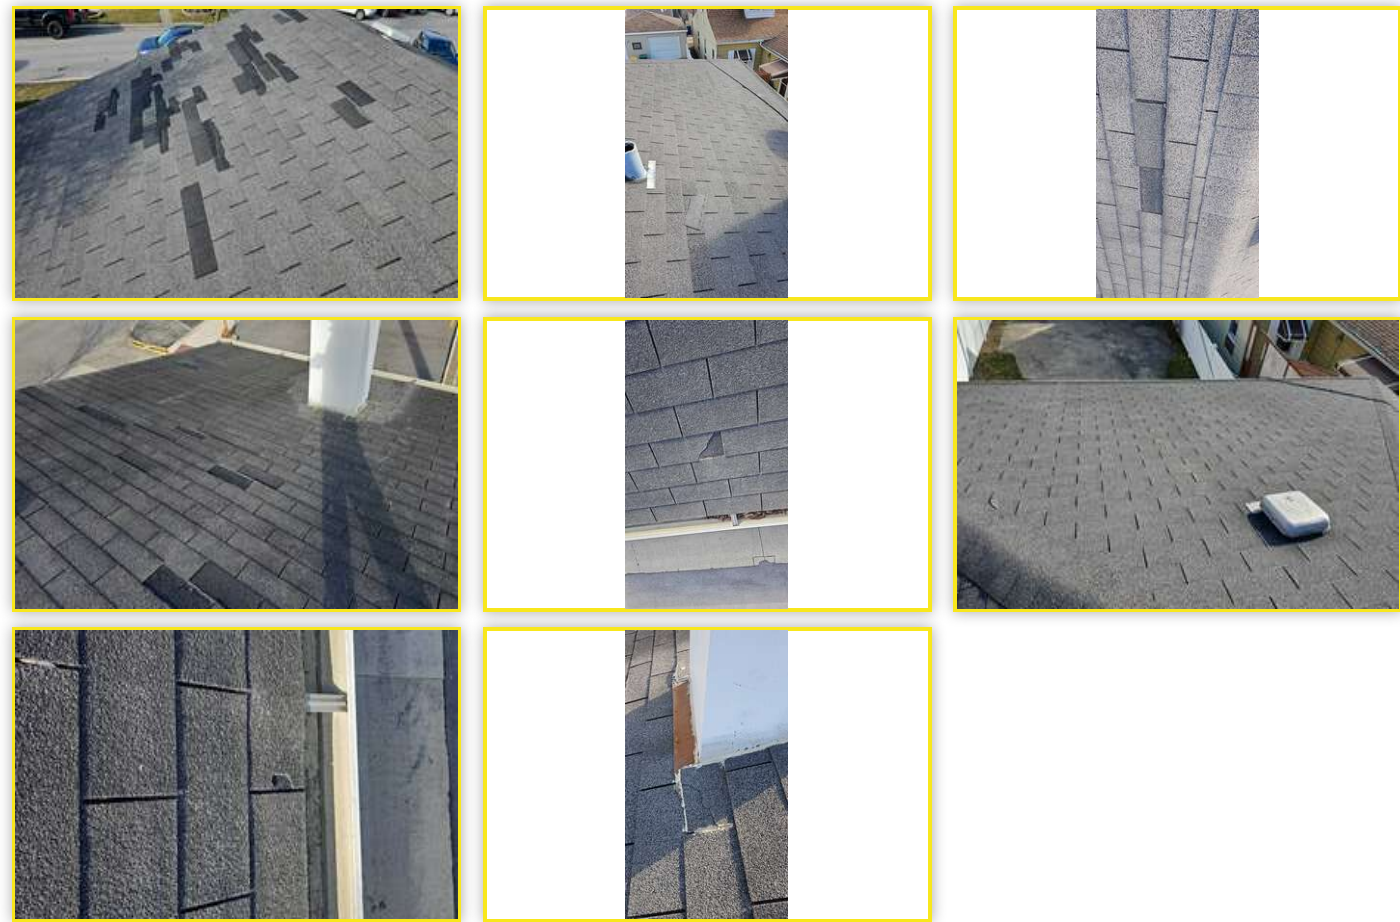
1. SHINGLES (WIND DAMAGE)  
At the time of inspection, one or more areas of the roof had creased/broken or missing shingle tabs from high winds. This can result in water damage to the roof framing. I recommend the affected area(s) be evaluated and repaired or replaced as needed by a qualified roofing contractor.

2. ROOF COVERING NEAR END OF LIFE  
The roof covering is old, and at the end of its typical life span at the time of inspection. The covering does need to be replaced soon. While it may last a year or so, some areas may need patching with tar as leaks develop.

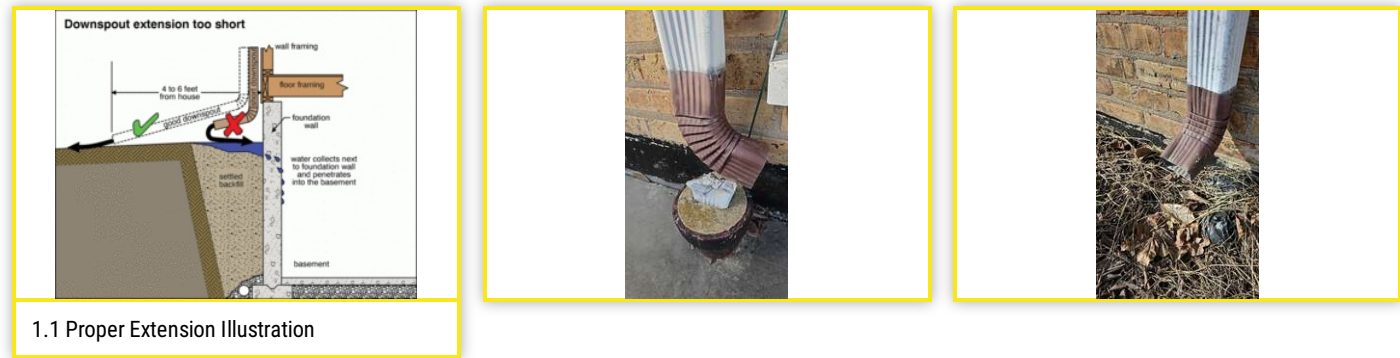
1.1 Proper Extension Illustration

One or more downspouts were too short around this the home, allowing roof drainage to discharge next to the foundation which can lead to further erosion, settlement, or water intrusion in these areas. I recommend proper extensions be installed by a qualified person.

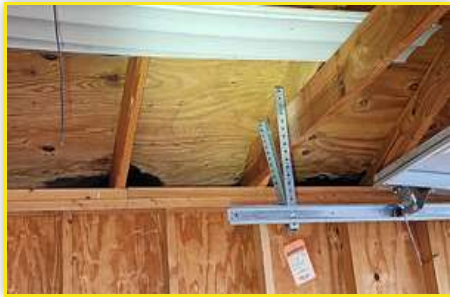
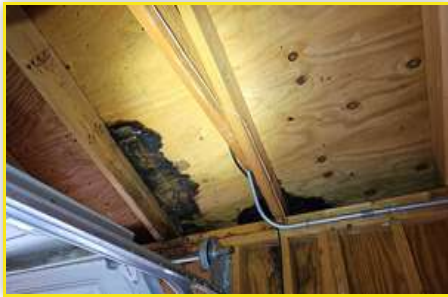
### 5.4.1 Water Stains

There was evidence of moisture damage at eaves. This is most likely due to a lack of drip edge flashing and gutters. I recommend repairing or replacement damaged sheathing as necessary and taking steps to prevent further damage such as gutter installation.

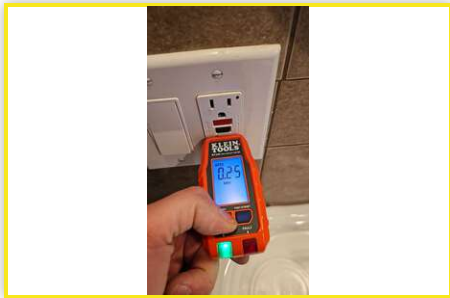
At the time of inspection, one or more bathroom GFCI electrical outlet made a buzzing sound when the reset button was tested. Recommended these GFCI receptacles are evaluated, repaired or replaced by a professional electrical contractor.

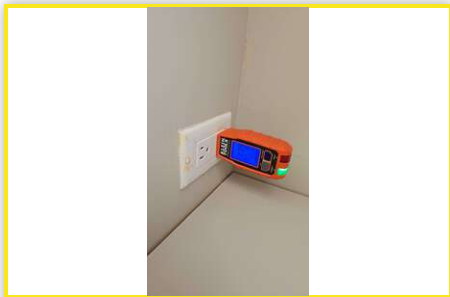
2.1 Near toilet

### 7.1.2 No bathroom GFCI (Required)

The bathroom did not have GFCI electrical outlets installed. GFCI protection was first required in bathrooms in 1975. Because the outlets in this bathroom are brand new or missing from the home as it was built after 1975, I recommend the bathroom outlet(s) be replaced to include GFCI protection. All work should be done by a professional electrical contractor.

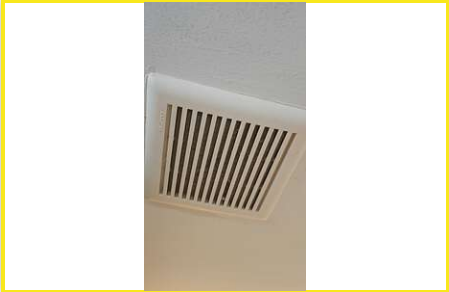
2. DIRTY BATHROOM FAN

The bathroom exhaust fan was dirty and restricted in air flow at the time of inspection. I recommend cleaning or replacement as needed by a qualified person.

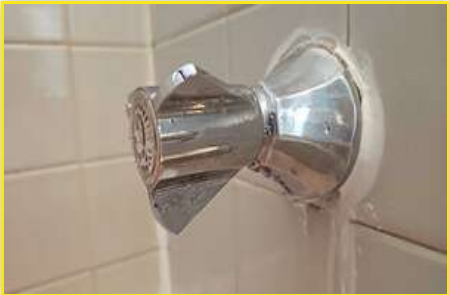
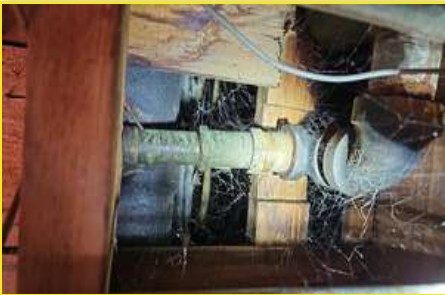
1.2 Going behind wall

The tub shut offs or handle leaks when it is operated. We recommend that the leaking valves be repaired or replaced by a plumbing contractor.

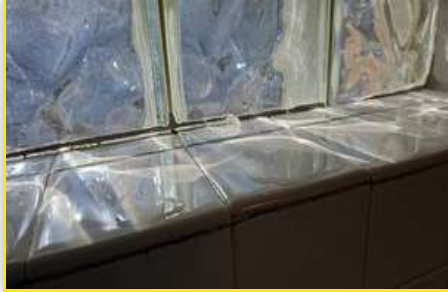
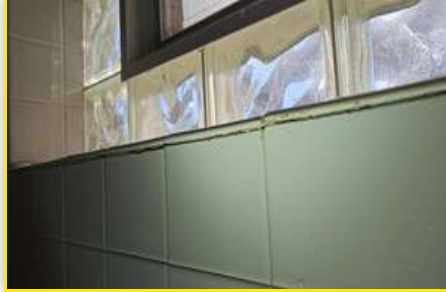
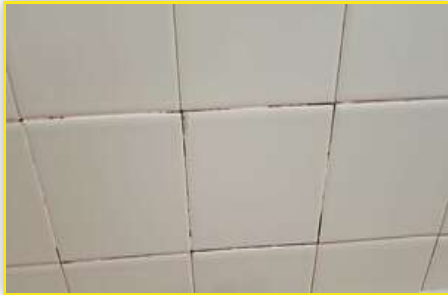
#### 1. SHOWER CAULK/GROUT DAMAGE

The caulking and/or grout used to seal the shower surround was deteriorated or cracked. I recommend a qualified contractor repair as necessary. to prevent leaks behind the wall.

#### 2. WINDOW SLOPE

The tile below the window is retaining water or sloping back towards the window. The tile should slope back in towards the shower so that water is not held against the outer wall/base of the window causing possible water damage and or wood rot.

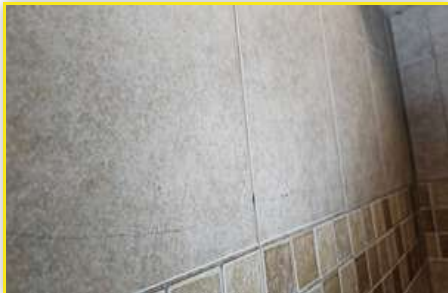
### 7.8.2 Cracked shower tiles

There one or more cracked tiles found in the shower at the time of the inspection. I recommend the cracked tiles be repaired or replaced as needed by a professional contractor.

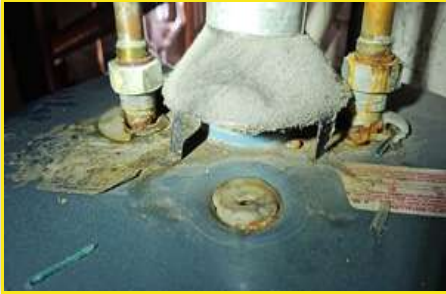
### 8.2.1 Backdrafting Signs Identified

There was back drafting noted at the bottom of the water heater flues. Signs can be condensate on mirror/glass, melting plastic components such as gaskets and dielectric unions, or corrosion and white deposits on or around flue. Also taking a lighter and lighting it by the diverter, the flame blows out, indicating back drafting. Back drafting allows combustion gases back into the home which can be a safety hazard. Evaluation and repairs should be made by a professional HVAC or plumbing contractor.

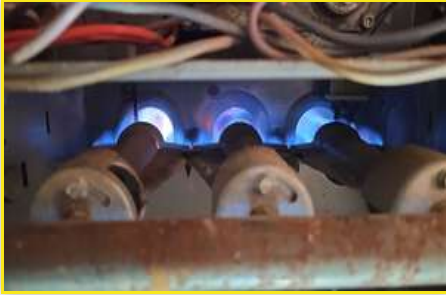
The furnace was at or past its recommended lifespan. It was visibly old and dirty and should be serviced at the least. I recommend the furnace be evaluated and serviced or replaced as needed by a professional HVAC contractor to ensure the best possible working condition.

#### 2. FURNACE FLAME CONDITION VARIED (SERVICE NEEDED)

At the time of inspection, the flames from the furnace gas burners were not a pretty blue and had orange/yellow flames. This indicates that the burners are not operating properly or efficiently and service may be needed. I recommend the burners and unit be evaluated and serviced or replaced as needed, by a professional HVAC contractor.

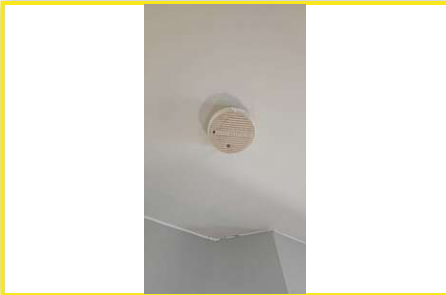
### 11.9.1 Expired smoke detectors

One or more smoke detectors present in this home are past the recommended life span. It is important to replace any smoke detectors that have turned yellow in color, as this is a feature by the manufacturer indicating that they are older than 10 years.

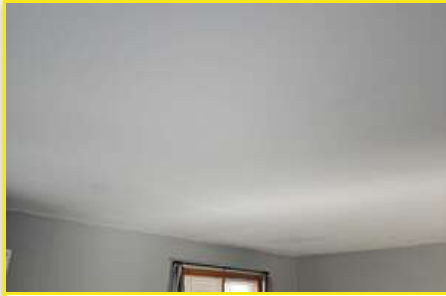
1.1 No switched receptacle found for lamp

### 12.9.1 Lighting Missing

Lighting was missing in one or more areas.

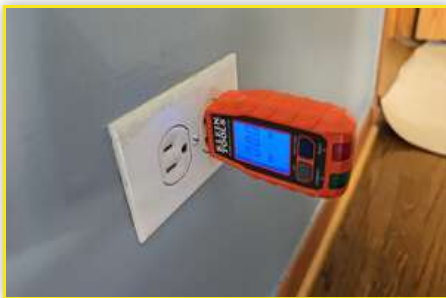
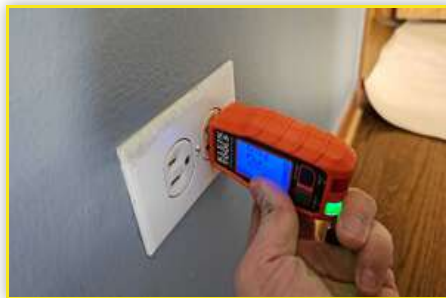
### 12.11.1 Outlet (Worn/Intermittent)

One or more receptacles were working intermittently or when the plug is wiggled. They can cause issues due to loose connections. The inspector recommends that this safety issue be repaired as needed by a professional electrical contractor.

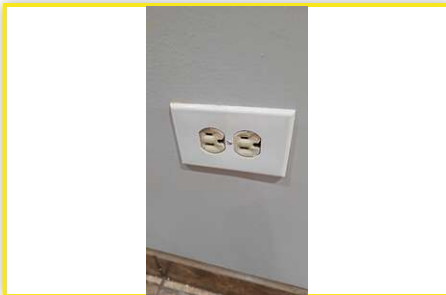
### 12.11.3 Outlet (Damaged)

One or more outlets were broken or damaged. This is a potential safety concern. The inspector recommends that the affected outlets be repaired as needed by a professional electrical contractor.

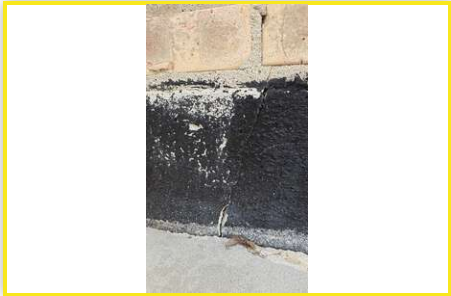
13.4.1 Minor cracks, sealing needed

One or more areas of the exterior foundation walls had minor cracks visible. These cracks can be sealed and monitored to prevent further erosion from water intrusion or wood destroying insects intrusion. A contractor can seal these cracks with foundation approved sealant products.

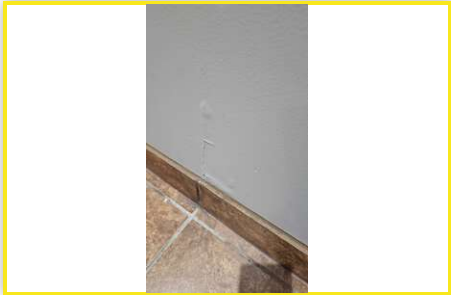
13.4.2 Water intrusion

One or more visible sign(s) of water intrusion were present at the time of inspection. I am unable to determine extent or how often it may occur. If not corrected, a wet basement can lead to costly issues such as foundation problems, mold and deterioration of floor system. A qualified water infiltration specialist should further investigate and repair as needed.

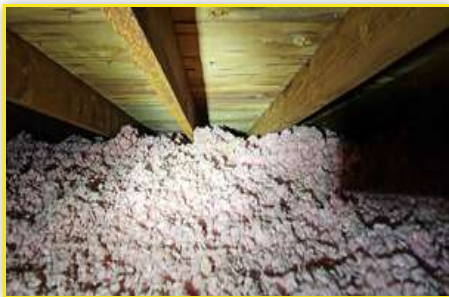
1.1 Proper Ventilation

At the time of inspection, all the soffit vents were covered by insulation. This is an improper condition that will cause the attic to get excessively hot and age the roof material faster than needed. The inspector recommend the installation of baffles or just pulling back the insulation.

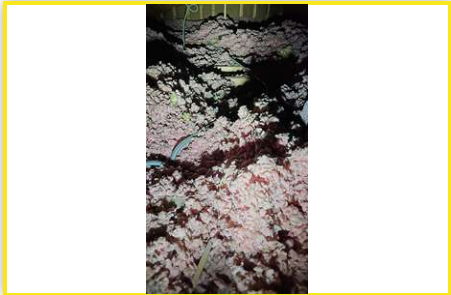
The insulation level installed in the attic was less than R-38 in areas because there were large gaps with little or no insulation. The home will be affected by the lack of insulation that will add to the cost per month for your heating and cooling needs. This will also make the home less comfortable. I recommend the attic insulation levels be updated as needed by a professional insulation contractor.

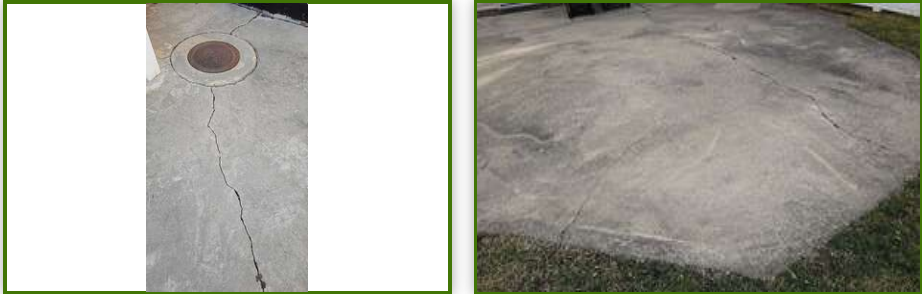
2.1.1 Patio cracking/spalling (seal) Low

Concrete patio surface had cracking or spalling visible in area(s)at the time of the inspection. Cracks should be filled with an appropriate concrete grade sealant to help prevent furtherdeterioration. Spallingcan be patched and in some cases replacement is the only repair since it will worsen over time as moisture breaks down the concrete.

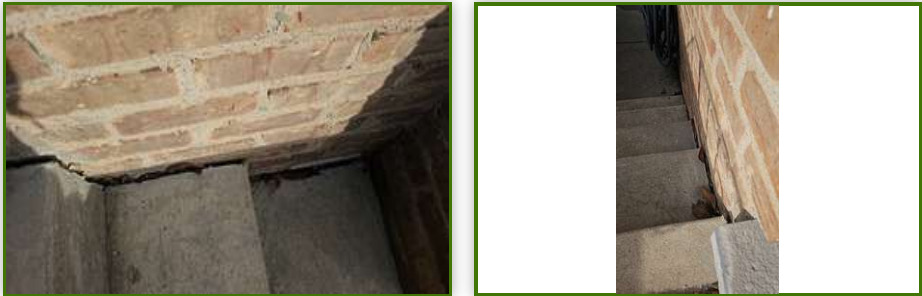
2.2.1 Walkway/Driveway Exterior (Deteriorated Sealant) Low

The walkway/driveway joint running along the bottom edge of the exterior of this home needs to sealed with an exterior grade sealant to avoid allowing water to seep down along the foundation.

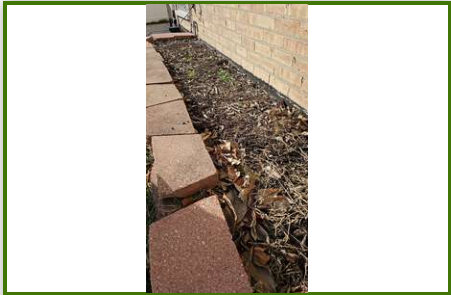
1.1 Negative grade (sloping toward the home)

2.4.1 Planter beds close to foundation Low

One or more planter beds were found next to the foundation. This can hold excessive moisture against the foundation and cause potential foundation issues.

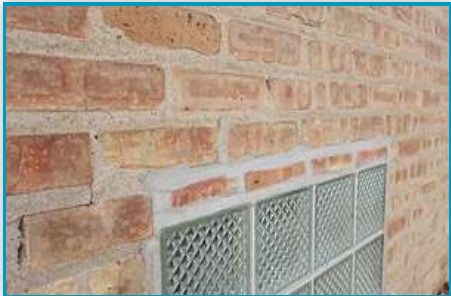
There were previous brick point-up repairs noted in areas. The repairs had not re-cracked at the time of inspection. Ask the seller for your knowledge when the repair was made. If it was recent then ask who performed the repair and what was determined to be the cause and continue to monitor. If it is an old repair then the sign that it has not cracked indicates that it may just have been typical settlement for the age of the home which has not moved since the original repair. Continue to monitor.

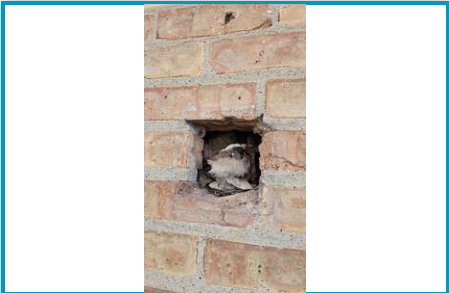
Location: LEFT SIDE (FACING FRONT)

The hole(s) in brick need closing off with sealant or liquid foam where lines for system components enter the home.

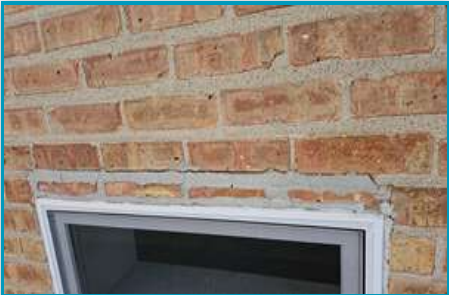
2.1 Unable to verify if a lintel is present

At the time of inspection, one or more bricks were damaged above windows due to missing/failing/rusted lintels or other reasons. I recommend the affected area(s) be evaluated and repaired or replaced as needed by a professional masonry contractor.

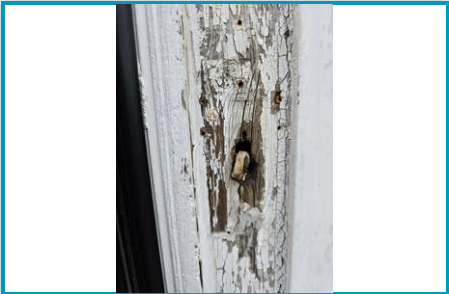
1.1 There used to be a doorbell here

The trim on this home was, cracked, deteriorated or damaged. I recommend the affected area(s) be evaluated and repaired or replaced as needed, by a professional contractor, to seal out moisture. Should you consider doing the repair yourself, see the DIY linked video to assist you in your decision.

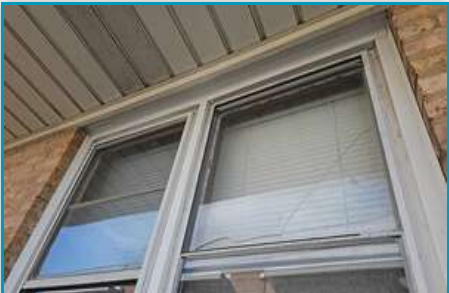
Location: LEFT SIDE (FACING FRONT)

One or more exterior windows had cracked panes. Broken glass should should be repaired or replaced to prevent injury and further damage. I recommend the affected area(s) be evaluated and corrected as needed by a professional contractor.

1.1 Storms

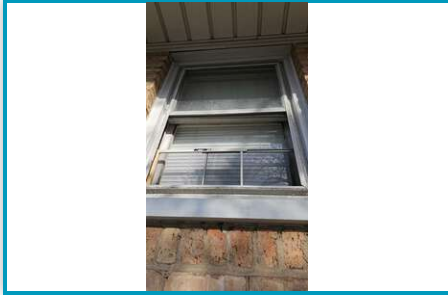
### 3.4.2 Missing pane

One or more window panes were missing at the time of inspection. This could be because they were damaged/broken and were removed purposely. I recommend replacement as needed.

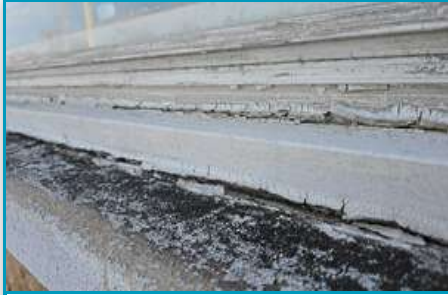
1.1 Windows

**2. PAINT FAILING IN SOME AREAS**

There were areas of paint that were peeling off. This can lead to deterioration of the material underneath if not kept sealed. Also keep in mind that even today, many exterior paints today are still allowed to contain lead in the ingredients. Peeling paint should be scraped, sanded, and re-finished.

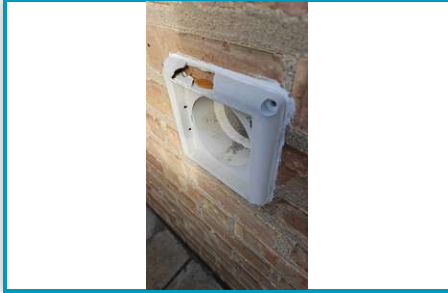
#### 2. DAMAGED EXTERIOR VENTS

At the time of inspection, one or more exterior vents were damaged. I recommend the affected damaged vents be evaluated and repaired or replaced as needed by a qualified person.

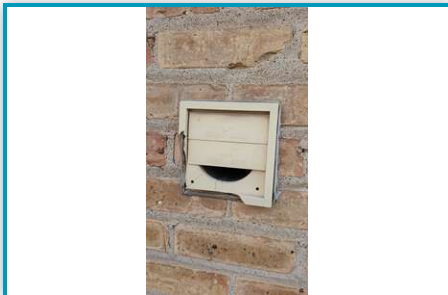
### 3.6.2 Missing vent flapper

At the time of inspection, one or more exterior vents was missing its flapper. I recommend that the missing vent flappers be replaced by a qualified person to prevent vermin intrusion or nesting.

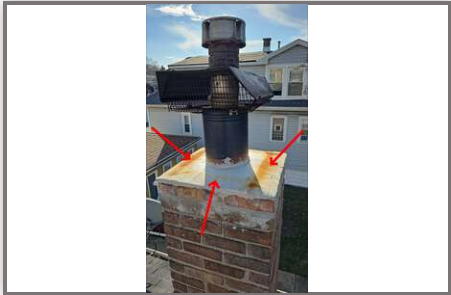
The cement crown on one or more chimney(s) is inadequate and will not direct water away from the structure. A chimney crown should overhang the stack by at least 1-2 inches and allow a capillary break for water to fall before weeping onto the brick. The cement should also be 2 inches thick and the thinnest and have a slope away from the flue opening. I recommend a qualified masonry contractor further evaluate and repair or replace as needed.

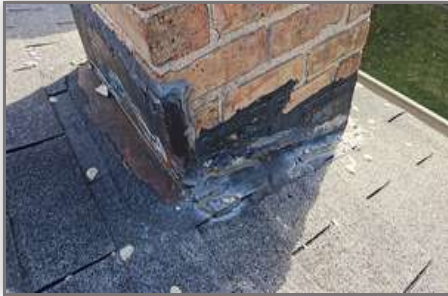
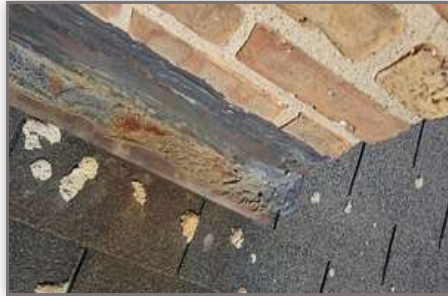
#### 4.2.1 Damaged, loose missing flashing

At the time of inspection, there was visible loose, damaged or deteriorated roof flashing, allowing for potential leakage, causing damage, decay or mold. The Inspector recommends that the affected area(s) be evaluated, replaced or repaired, as needed, by a professional roofing contractor.

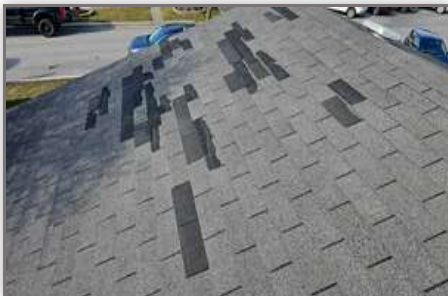
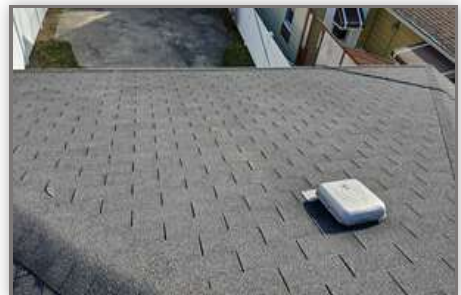
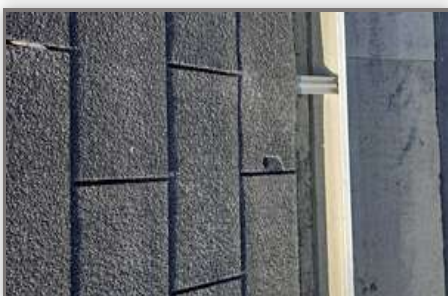
#### 4.5.1 Asphalt Composition Shingle(Multiple Defects)

The roof covering is old, and at the end of its typical life span at the time of inspection. The covering does need to be replaced soon. While it may last a year or so, some areas may need patching with tar as leaks develop.

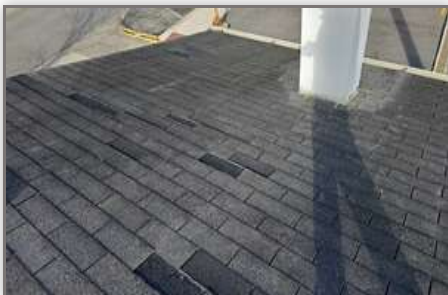
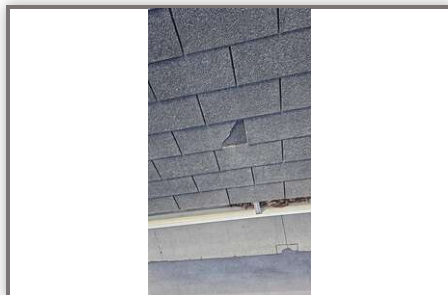
At the time of inspection, one or more areas of the roof had creased/broken or missing shingle tabs from high winds. This can result in water damage to the roof framing. I recommend the affected area(s) be evaluated and repaired or replaced as needed by a qualified roofing contractor.

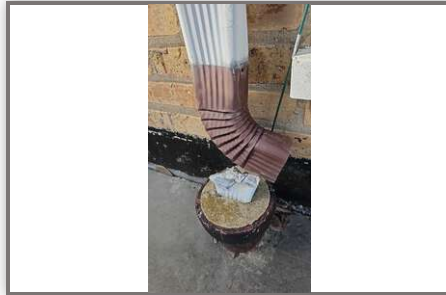
1.1 Proper Extension Illustration

One or more downspouts were too short around this the home, allowing roof drainage to discharge next to the foundation which can lead to further erosion, settlement, or water intrusion in these areas. I recommend proper extensions be installed by a qualified person.

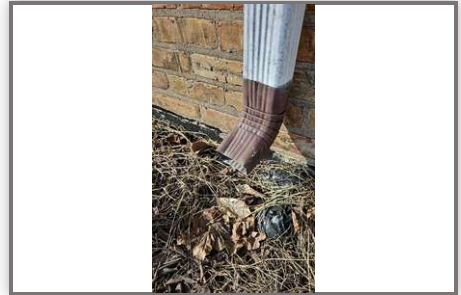
#### 4.6.1 Downspout Extension (Short/None/Missing)

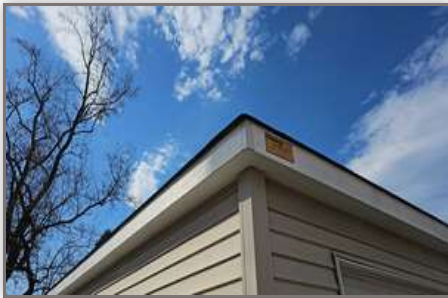
#### 4.6.2 Gutters (Some Missing)

Roof drainage system is missing. Runoff can cause deterioration to fascia, roof edge and siding, water damage/intrusion, as well as foundation related problems. I recommend installation of gutters by a qualified contractor.

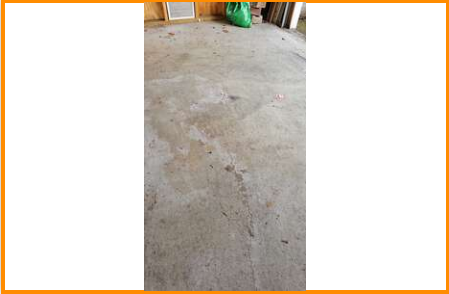
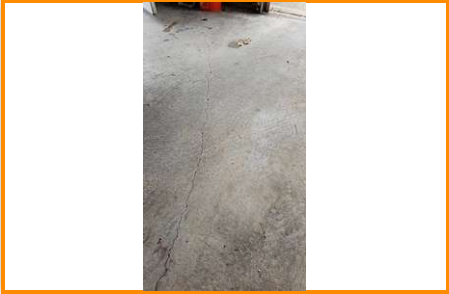
5.2.1 Floor, typical cracks

There were typical cracks identified throughout the garage floor. It is recommended to seal these cracks to prevent water penetration and expansion.

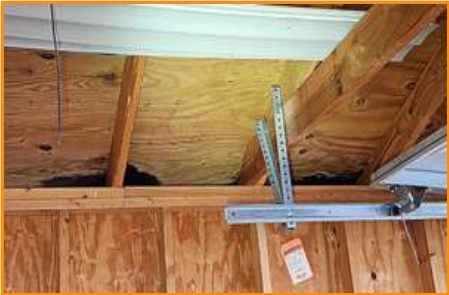
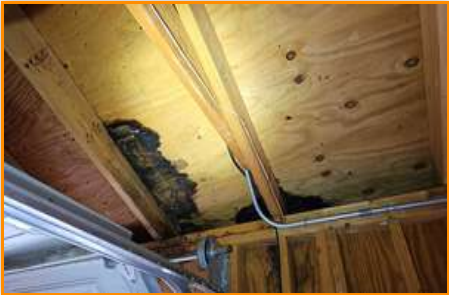
5.4.1 Water Stains

There was evidence of moisture damage at eaves. This is most likely due to a lack of drip edge flashing and gutters. I recommend repairing or replacement damaged sheathing as necessary and taking steps to prevent further damage such as gutter installation.

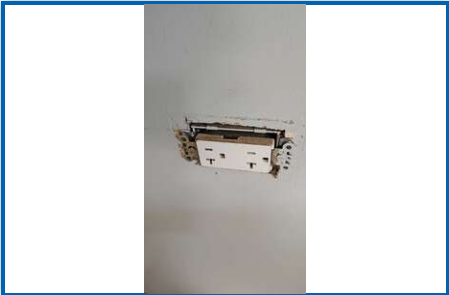
6.1.1 Missing cover plate

One or more receptacles or switches had a missing cover plate at the time of inspection. Outlets should be covered to prevent accidental electrical shock.

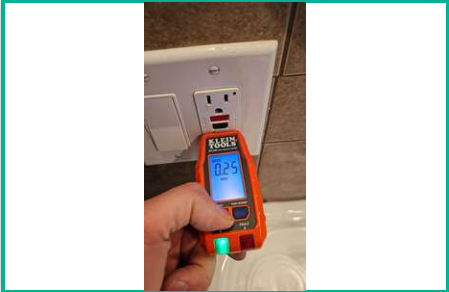
At the time of inspection, one or more bathroom GFCI electrical outlet made a buzzing sound when the reset button was tested. Recommended these GFCI receptacles are evaluated, repaired or replaced by a professional electrical contractor.

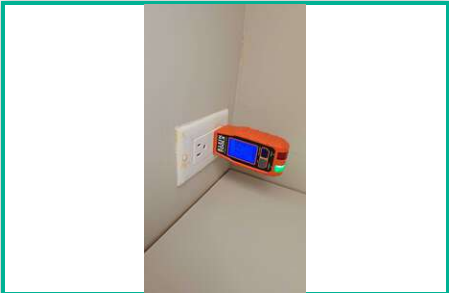
2.1 Near toilet

The bathroom did not have GFCI electrical outlets installed. GFCI protection was first required in bathrooms in 1975. Because the outlets in this bathroom are brand new or missing from the home as it was built after 1975, I recommend the bathroom outlet(s) be replaced to include GFCI protection. All work should be done by a professional electrical contractor.

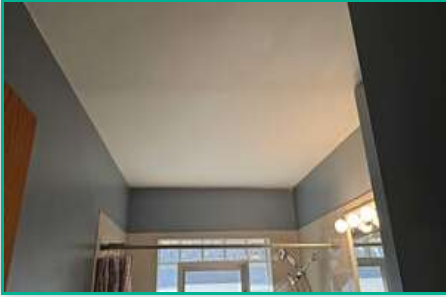
### 7.3.1 Bathroom window only (Install fan)

There was no bath fan installed in a bathroom with a shower and/or bath. A window in the bathroom may not provide sufficient ventilation especially during cold and/or windy days which could result in moisture build-up that can lead to mold, mildew, bacteria or fungal growth. While not required, I highly recommend a professional contractor install an exhaust fan in the bathroom.

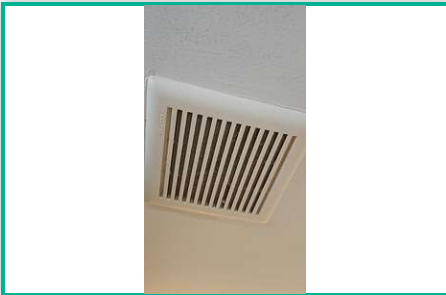
### 7.3.2 Ventilation(Multiple Defects)

The bathroom fan was not operable or responding to the switch. I recommend repair or replacement as needed by a professional electrical contractor.

The bathroom exhaust fan was dirty and restricted in air flow at the time of inspection. I recommend cleaning or replacement as needed by a qualified person.

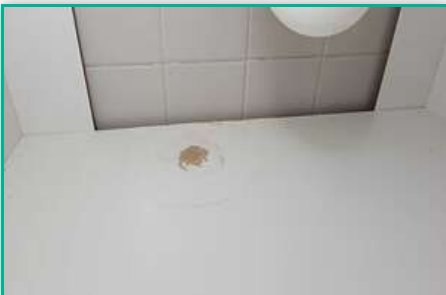
### 7.4.1 Cabinet floor minor damage (No moisture)

At the time of the inspection, the under-sink cabinet floor in the bathroom had minor damage from past moisture that appears to have been corrected. Recommended that the damaged area is repaired as needed and monitored to minimize further damage.

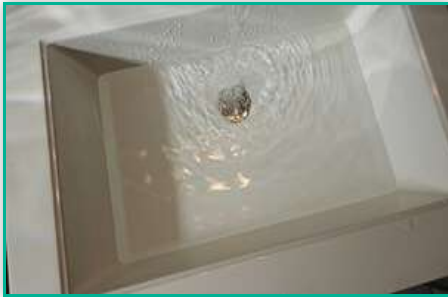
#### 7.5.1 No sink overflow

The bathroom sink did not have an over flow installed near the top of the sink to avoid overflowing the sink. There are several European sinks that do not have this feature. Be careful not to leave the water running in this sink.

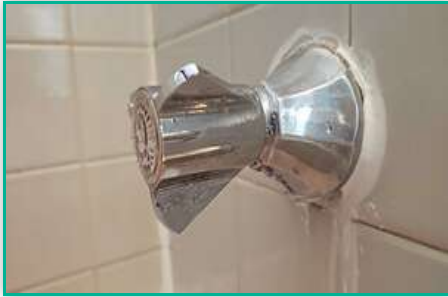
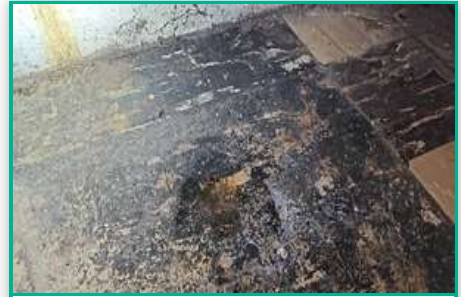
1.2 Going behind wall

The tub shut offs or handle leaks when it is operated. We recommend that the leaking valves be repaired or replaced by a plumbing contractor.

1.3 Dripping in basement

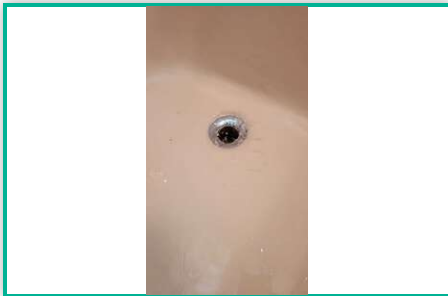
At the time of the inspection, the tub stopper was missing or inoperable. Without the stopper installed, I am unable to fill the tub to check drain for slow areas or leaks.

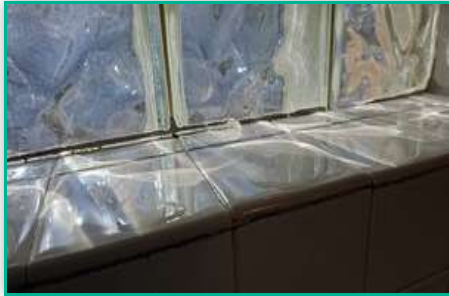
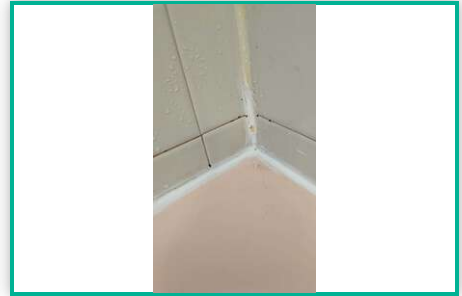
### 7.8.1 Shower(Multiple Defects)

The tile below the window is retaining water or sloping back towards the window. The tile should slope back in towards the shower so that water is not held against the outer wall/base of the window causing possible water damage and or wood rot.

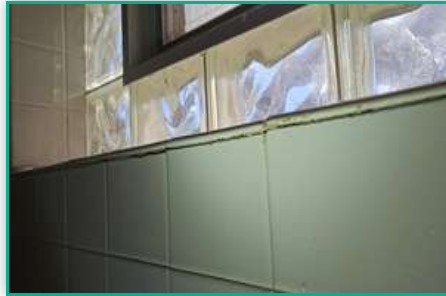
The caulking and/or grout used to seal the shower surround was deteriorated or cracked. I recommend a qualified contractor repair as necessary. to prevent leaks behind the wall.

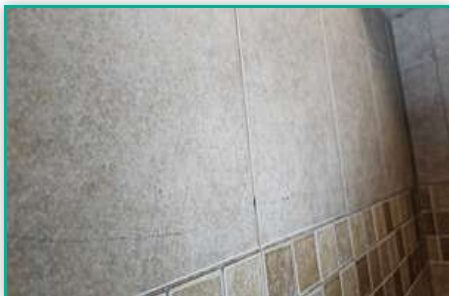
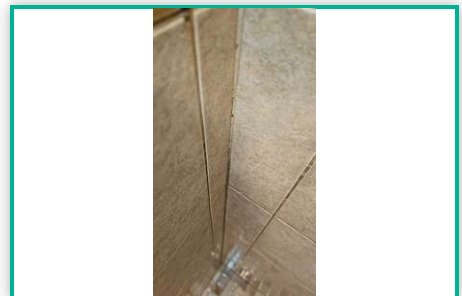
### 7.8.2 Cracked shower tiles

There one or more cracked tiles found in the shower at the time of the inspection. I recommend the cracked tiles be repaired or replaced as needed by a professional contractor.

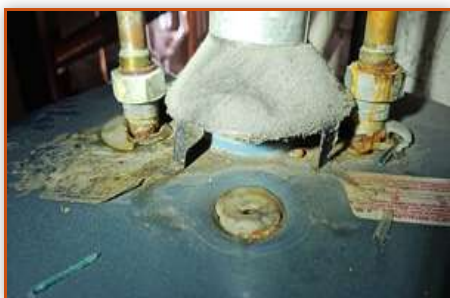
There was back drafting noted at the bottom of the water heater flues. Signs can be condensate on mirror/glass, melting plastic components such as gaskets and dielectric unions, or corrosion and white deposits on or around flue. Also taking a lighter and lighting it by the diverter, the flame blows out, indicating back drafting. Back drafting allows combustion gases back into the home which can be a safety hazard. Evaluation and repairs should be made by a professional HVAC or plumbing contractor.

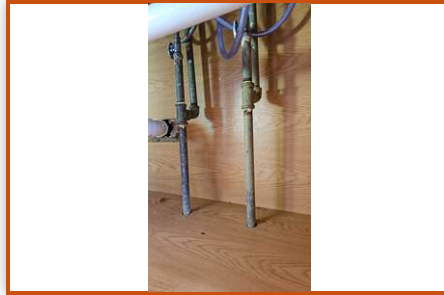
1.1 Galvanized Illustration

1. Galvanized piping noted in the home - Two things happen to galvanized pipes as they age. First, minerals tend to slowly build up on the inner walls of the pipe, decreasing the inside diameter. In extreme cases, this can slow the water flow to a trickle. The other common problem with galvanized pipes is corrosion at the joints. In the process of cutting the threads for the pipe fittings, the protective galvanizing is cut away, exposing bare metal. Over time, these threaded joints will corrode and eventually break. Galvanized piping has a life expectancy of 50 years. If your home has surpassed this age, you should anticipate the replacement of the piping in the not so distant future. Galvanized piping rusts from the inside out. This is what causes the water to have the rust color when operating a faucet. The life expectancy of galvanized piping is 40 to 50 years. I recommend having a licensed plumbing contractor further evaluate the plumbing supply system and make repairs or replace as needed.

rusting of galvanized pipe can greatly reduce water pressure and will eventually cause leaks as rust creates holes in the pipe walls

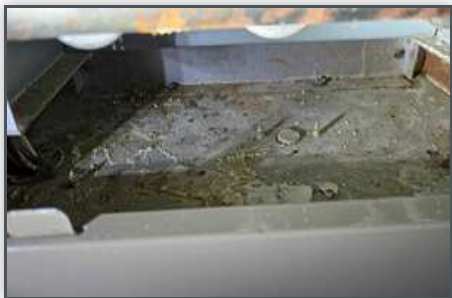
Unable to determine the size and age of the unit due to the label being faded or missing at the time of inspection. Ask the seller the if they are aware of the age of the unit to determine an estimated life span of the unit. Note: Furnaces of this type have expected service lives of 15 to 25 years. Any component of a heating system which is over 15 years age is categorized as being in fair condition, primarily due to its increased likelihood of breakdown and need for replacement in the future. Any service life in excess of 20 years is in the realm of good fortune only and should be viewed as such.

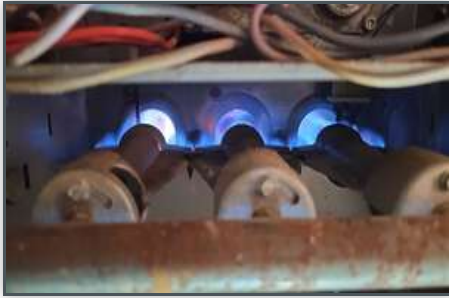
At the time of inspection, the flames from the furnace gas burners were not a pretty blue and had orange/yellow flames. This indicates that the burners are not operating properly or efficiently and service may be needed. I recommend the burners and unit be evaluated and serviced or replaced as needed, by a professional HVAC contractor.

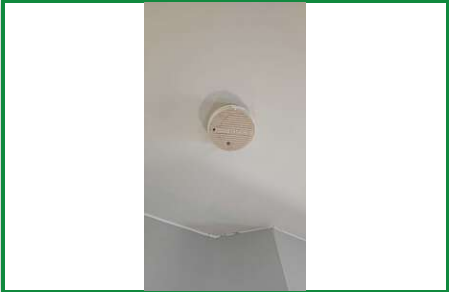
One or more smoke detectors present in this home are past the recommended life span. It is important to replace any smoke detectors that have turned yellow in color, as this is a feature by the manufacturer indicating that they are older than 10 years.

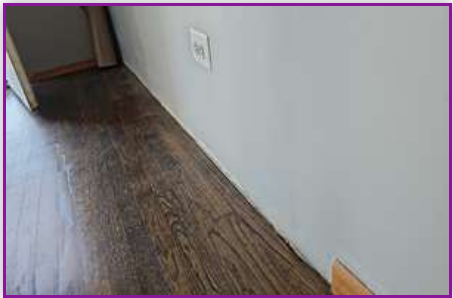
Interior trim is missing in one or more areas. The inspector recommends having a qualified contractor install trim where it is missing.

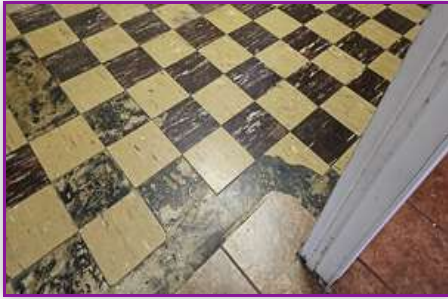
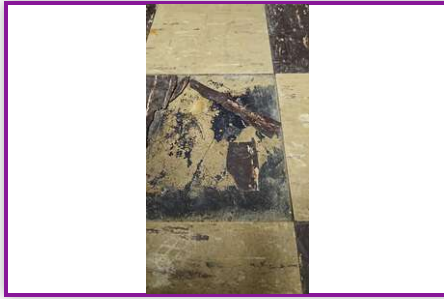
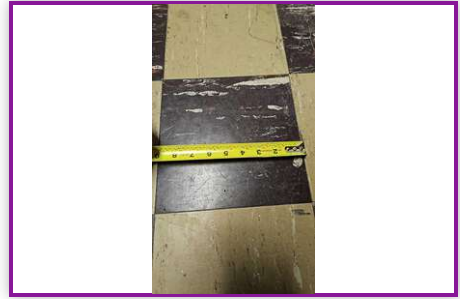
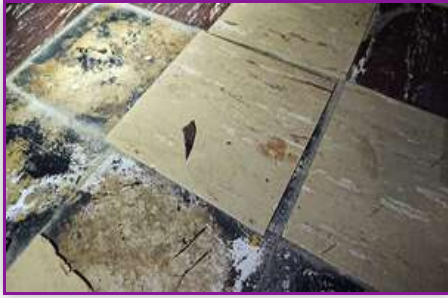
**Comment Location - BASEMENT**

The 9" tile at basement possibly contains asbestos. While we did not inspect or determine that materials are asbestos, I would treat it as such until a certified specialist can further investigate and verify. Asbestos is friable and can enter the air in particles which is unhealthy to breath or can cause severe health issues. I recommend mitigation or encapsulation as needed.

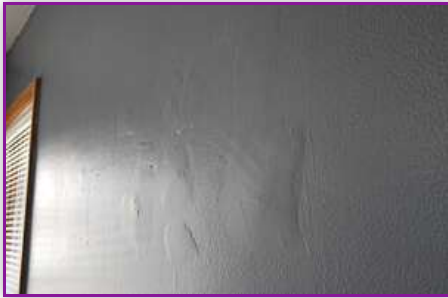
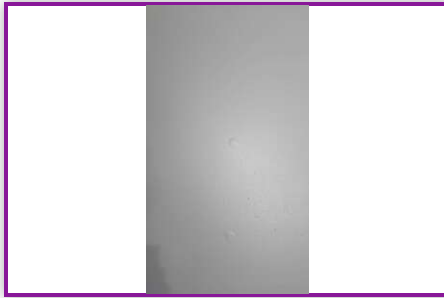
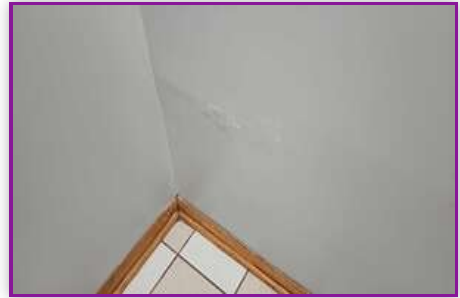
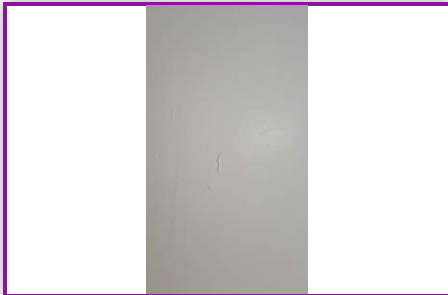
## 12.4.1 Damaged/poor repairs

**Comment Location - THROUGHOUT THE HOME**

There were areas in one or more rooms in the residence where the wall had cracking, damage, or repairs that have been done poorly. The inspector recommends that these areas are evaluated and repaired as needed by a professional contractor.

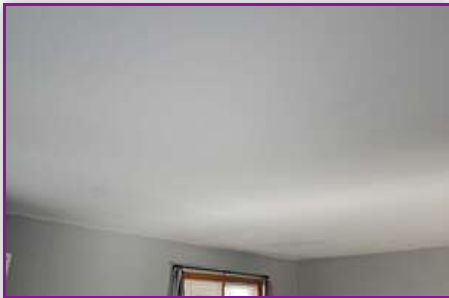
1.1 No switched receptacle found for lamp

### 12.9.1 Lighting Missing

Lighting was missing in one or more areas.

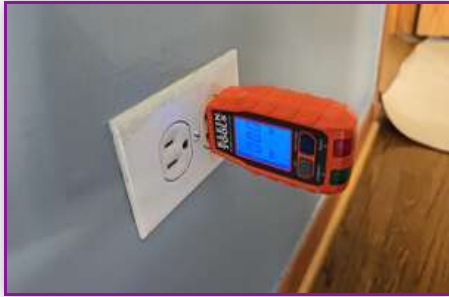
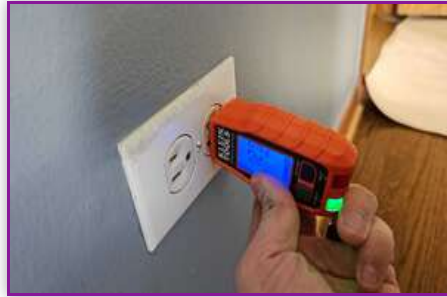
### 12.11.1 Outlet (Worn/Intermittent)

#### Comment Location - FRONT BEDROOM

One or more receptacles were working intermittently or when the plug is wiggled. They can cause issues due to loose connections. The inspector recommends that this safety issue be repaired as needed by a professional electrical contractor.

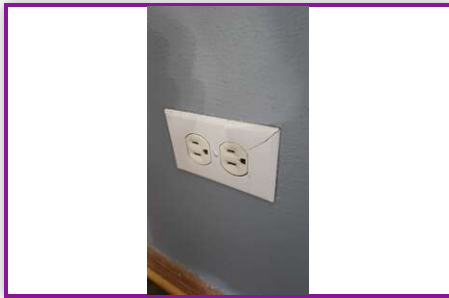
### 12.11.2 Cracked coverplate

#### Comment Location - FRONT BEDROOM

There was one or more outlet(s) with a cracked coverplate at the time of inspection. I recommend the cracked or damaged coverplate(s) be replaced as needed by a qualified person.

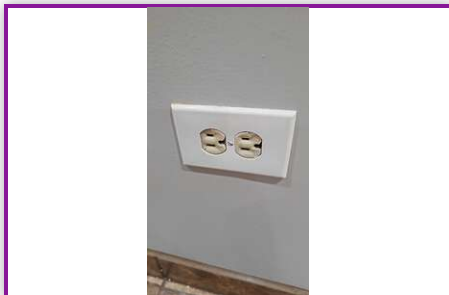
### 12.11.3 Outlet (Damaged)

#### Comment Location - BASEMENT

One or more outlets were broken or damaged. This is a potential safety concern. The inspector recommends that the affected outlets be repaired as needed by a professional electrical contractor.

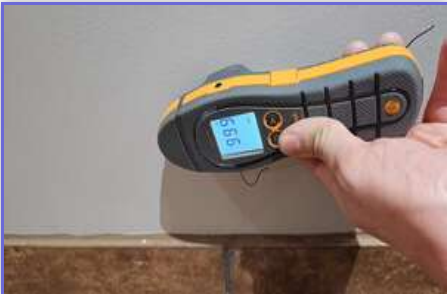
One or more visible sign(s) of water intrusion were present at the time of inspection. I am unable to determine extent or how often it may occur. If not corrected, a wet basement can lead to costly issues such as foundation problems, mold and deterioration of floor system. A qualified water infiltration specialist should further investigate and repair as needed.

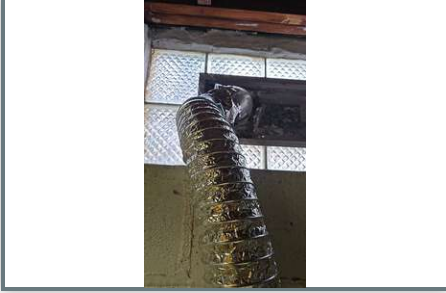
#### **Comment Location** - BASEMENT

Corrugated foil material hose connectors are not rated for the heat that most new dryer installations put out today. The corrugated material also clogs more easily than rigid, smooth walled ducting. This may lead to a fire hazard. I recommend replacement for sheet metal such as galvanized steel or flexible, semi-rigid aluminum.

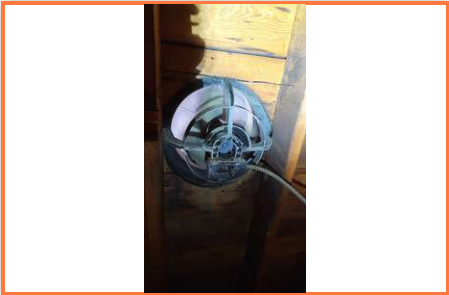
#### Comment Location - ATTIC

Note: Unable to test the attic power fan at the time of inspection. The power fan is controlled by a thermostat and the temperature at the time of inspection was below the thermostats lowest setting.

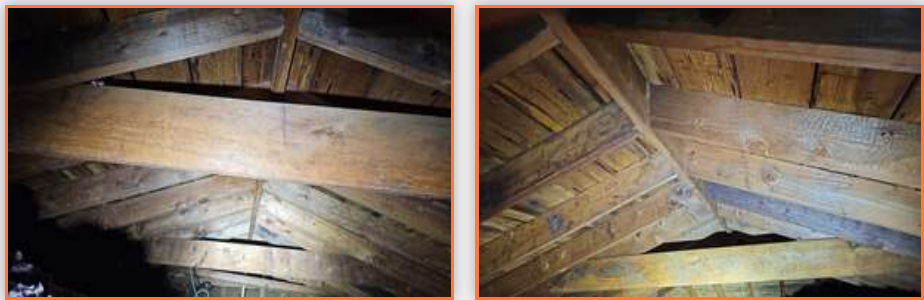
15.3 Roof Structure

2/8 Rafters

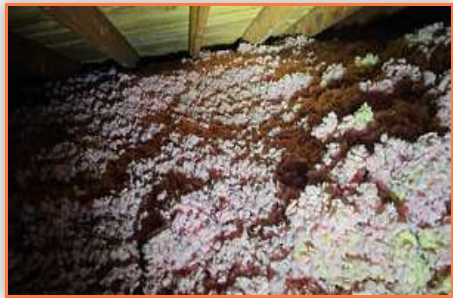
15.4 Attic Insulation Type

Blown, Fiberglass

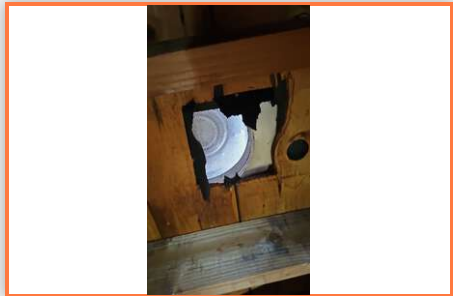
15.5 Attic Ventialtion System

Soffit Vents, Thermostatically Controlled Fan, Roof vents
