**Alpha Home Inspections**  
<http://www.inspectwithalpha.com>  
(630) 340-7723  
[imiranda@inspectwithalpha.com](mailto:imiranda@inspectwithalpha.com)

**123 Main Street, Pleasantville, Illinois 12345**  
**Residential Inspection**  
**Prepared for**  
**John Doe, Jane Doe**  
**Dec 02, 2021 at 08:00 AM**

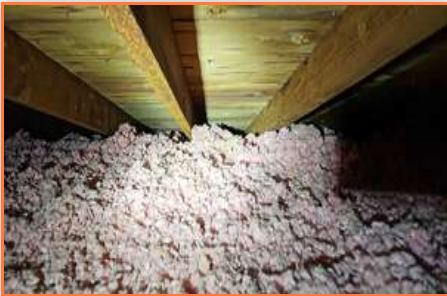
1.1 Proper Ventilation

At the time of inspection, allthe soffit vents were covered by insulation. This is an improper condition that will cause the attic to get excessively hot and age the roof material faster than needed. The inspector recommend the installation of baffles or just pulling back the insulation.

**Recommended amount of attic ventilation**

the total vent area is often recommended to be 1/300 of the floor space of the attic
